# Manhole Inspection Summary

Manhole # S35A\_\_032MH

Insp Date: **11/14/08 10:38 AM**

**Location** Address: **610 w calvert st**

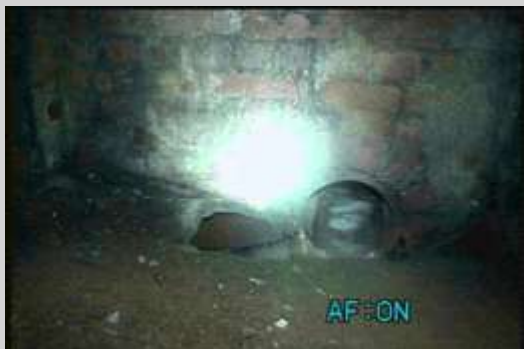
3 O'Clock Inflow

10 in. Circular Gravity Sewer  
Pipe In @ 3 O'Clock

Pipe Height: 0 (in.) Direct

Pipe Material: **Clay** ☐ Pipe Lined

Infiltration: **None** Pipe Seal Cond: **Unknown**
